Differential Exposure of Brickwork to Hydrogen Cyanide during World War Two

[Nicholas Kollerstrom](#), [Germar Rudolf](#)

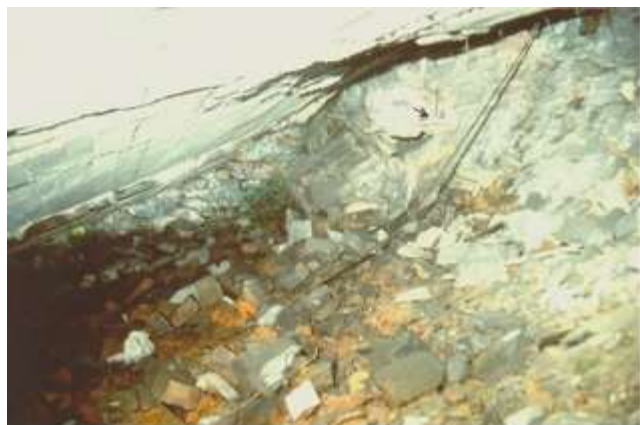
Fig. 1: Interior photograph taken from the ruins of Morgue 1 (alleged "gas chamber") of Crematorium II. The arrow points to a sample taking location by Germar Rudolf. (© 1991 Karl Philipp)

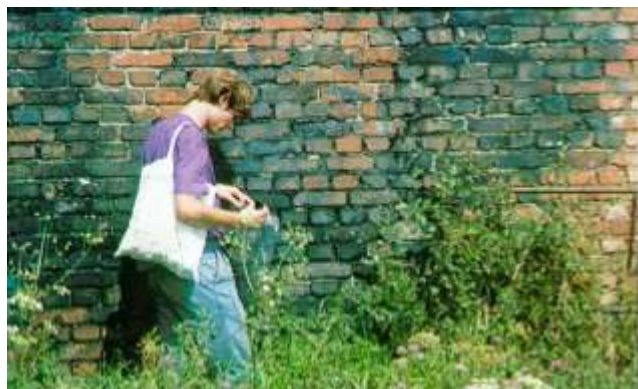
Fig. 3: Exterior southwest wall of the Zyklon B disinfestation wing of BW 5b in the Birkenau camp\ (© 1991 Karl Philipp)

Sample 17 was taken from the southern wall of the delousing wing of the hygiene building BW 5b at Auschwitz-Birkenau, a wall intensely exposed to the elements, as the winds and the rain come primarily
